RED METAL RESOURCES LTD.

**NI 43-101 UPDATED TECHNICAL REPORT
ON THE
FARELLÓN PROJECT
REGION III, CHILE**

**MARCH 30, 2012
REVISED MAY 04, 2012**

**By
William J. Lewis B.Sc., P.Geo.**

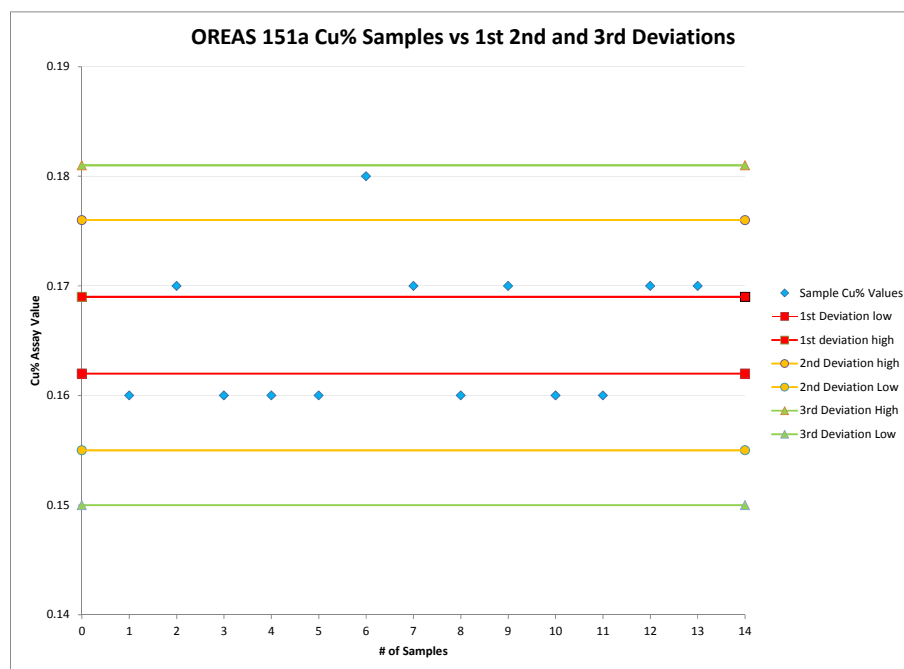
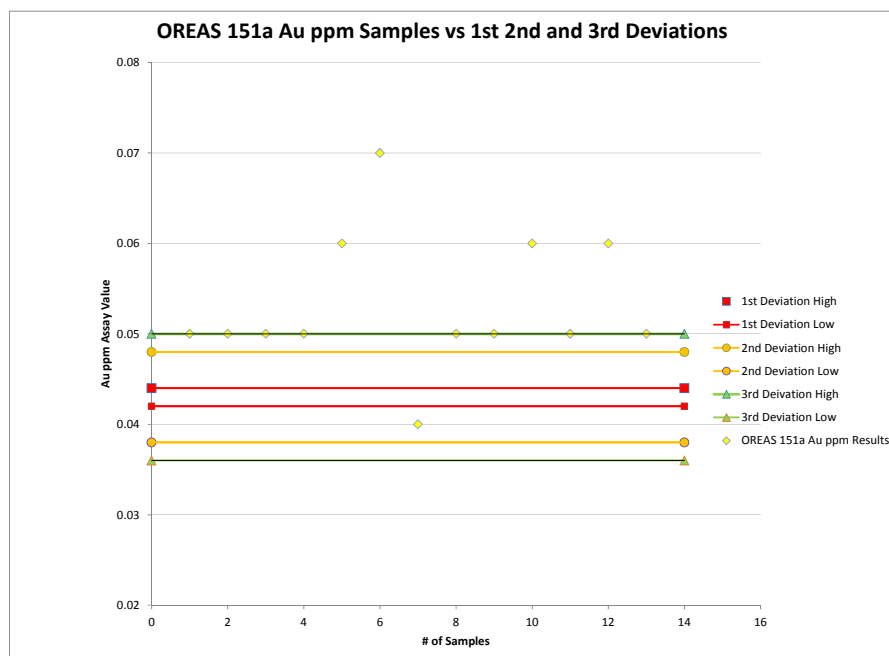
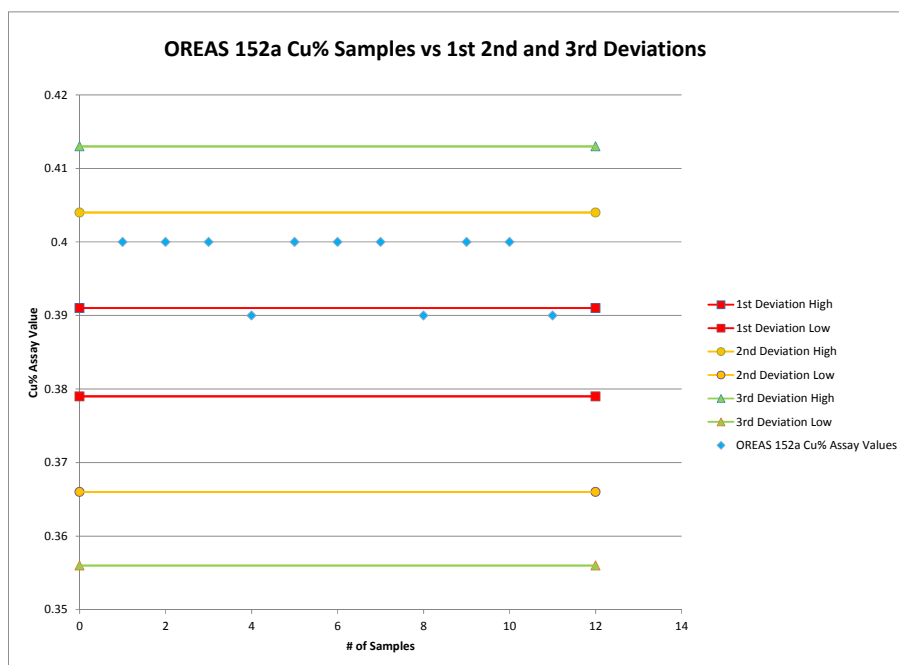
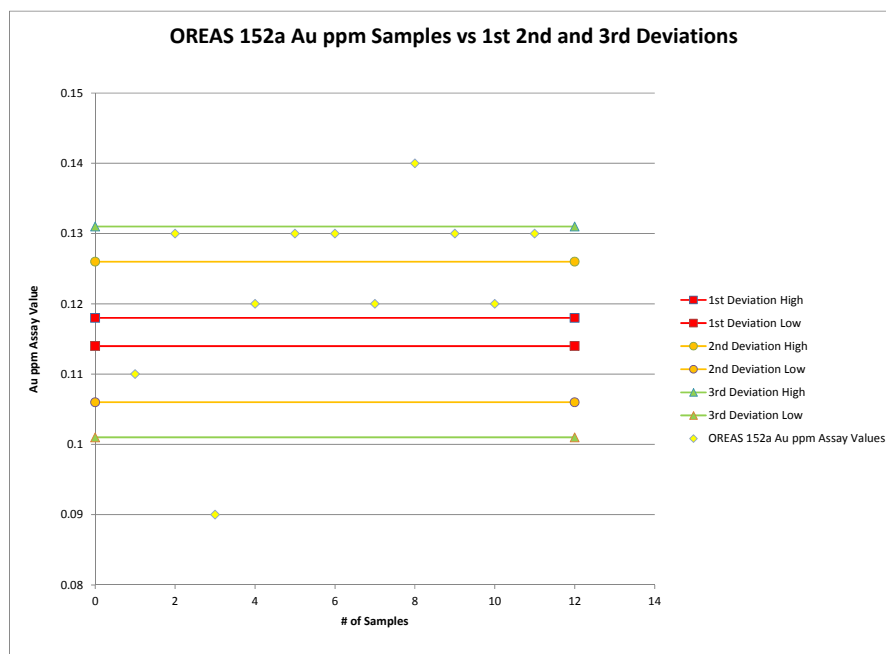
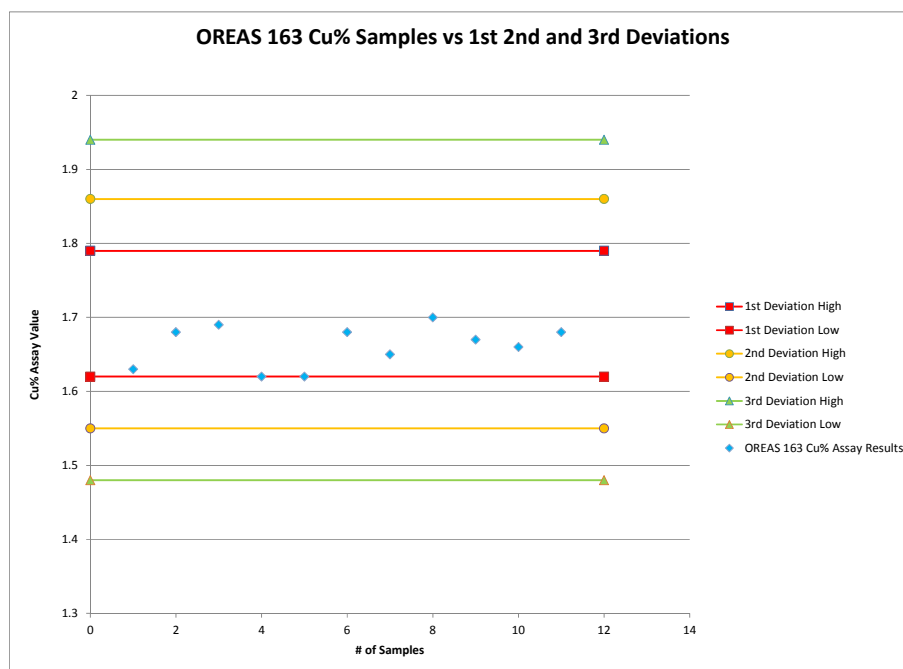
Figure 11.1
Graph of the Copper Assay Results for Standard Reference Sample OREAS 151a

Figure 11.2
Graph of the Gold Assay Results for Standard Reference Sample OREAS 151a

Figure 11.3
Graph of the Copper Assay Results for Standard Reference Sample OREAS 152a

Figure 11.4
Graph of the Gold Assay Results for Standard Reference Sample OREAS 152a

Figure 11.5
Graph of the Assay Results for Standard Reference Sample OREAS 163

A total of 35 standard reference samples were submitted to Geoanalitica in Coquimbo for analysis during the 2011 drilling program. Table 11.3 summarizes the assay results for the 35 standard reference samples submitted. Figures 11.1 through 11.5 graphically show the laboratory assays reported for the three standards. The number of standards submitted is statistically too small to support definitive conclusions. However, the results do appear to indicate that the assays obtained for both copper and gold at Geoanalytica are reliable and that in general no assay errors were encountered.

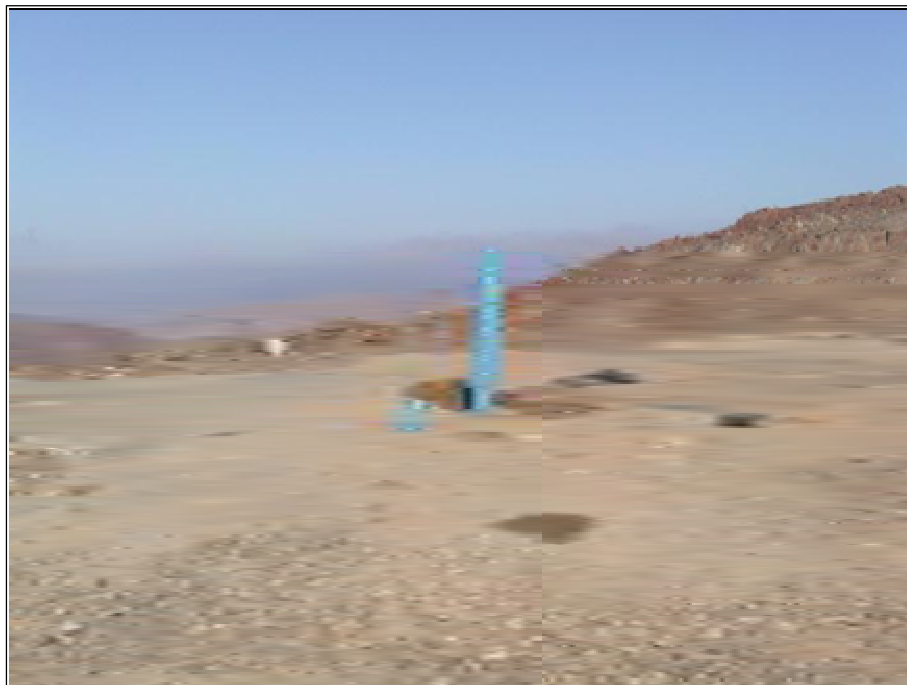
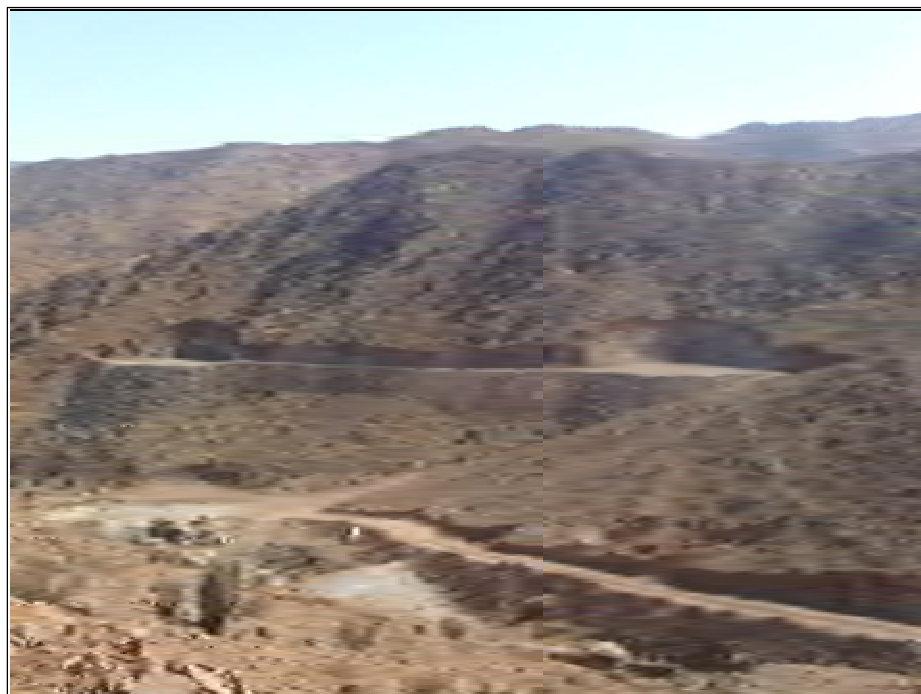
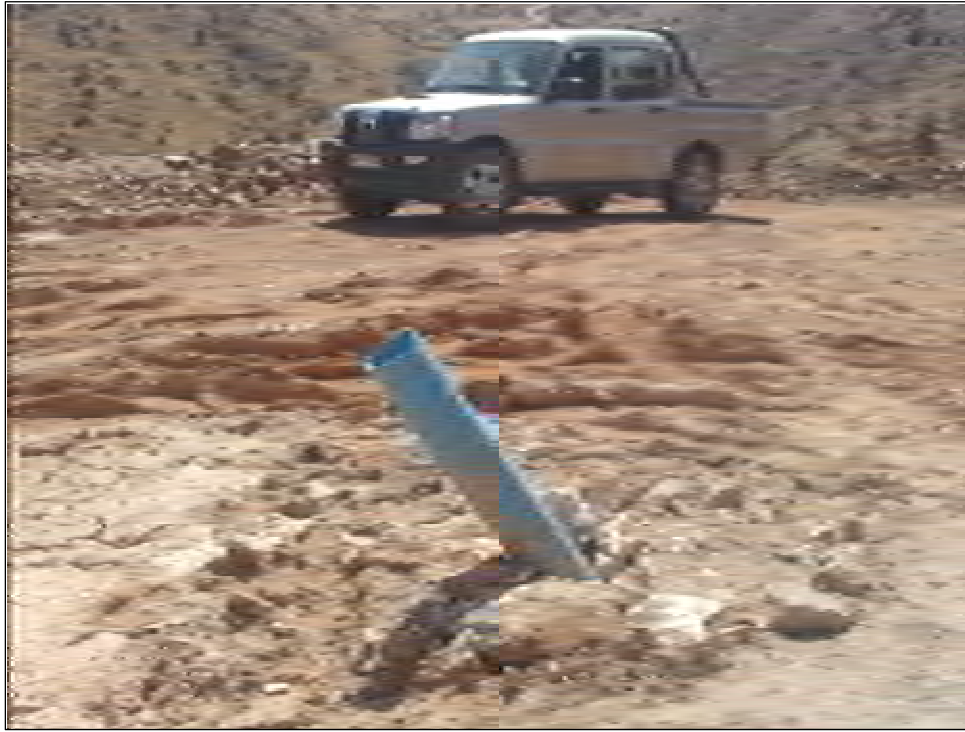
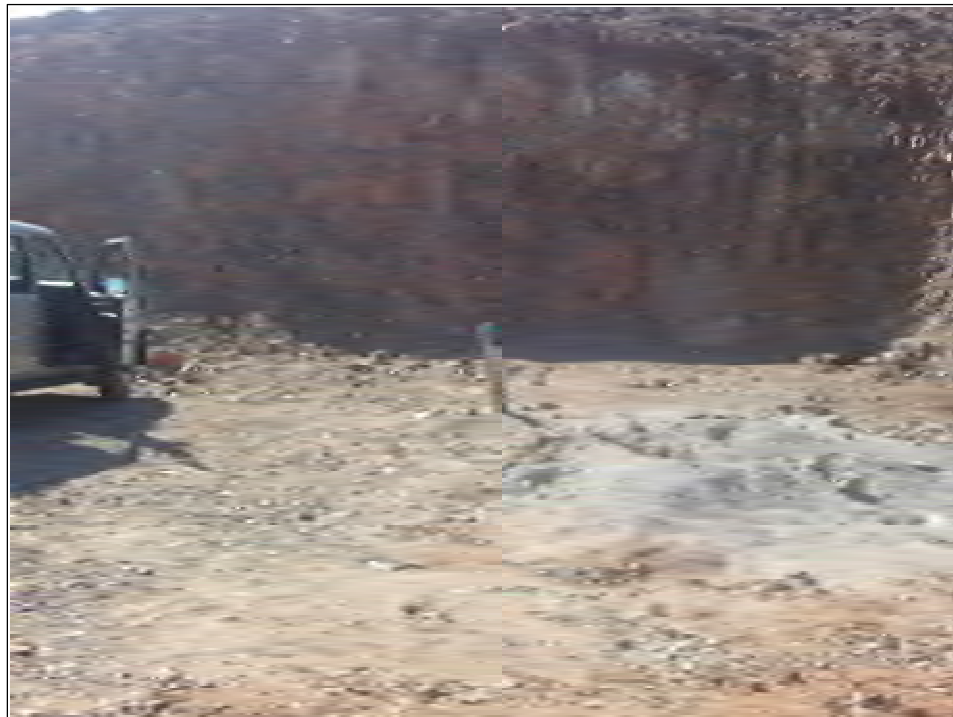
Figure 12.1
Collars for Holes FA-11-006 and FA-11-007

Figure 12.2
Collars for Holes FA-11-004 (Right) and FA-11-010 (Left)

Figure 12.3
Collar for Hole FA-11-002

Figure 12.4
Collar for Hole FA-11-011

During the second site visit, the drill locations were inspected and discussions related to the QA/QC program and results, further exploration and geology were undertaken. Figures 12.1 through 12.4 are photographs of a number of drill collars and platforms inspected during the site visit. Figures 12.5 through 12.7 show the core storage and logging area in Vallenar.
